Vermont Yankee – Engineering Department

To File UND2002-042 07 Date February 7, 2002
From Enrico Betti, Tom Marsteller, Joe Habich Memo# MSD 2002/002
W.O.# _____

Subject Condenser Long Term Plan

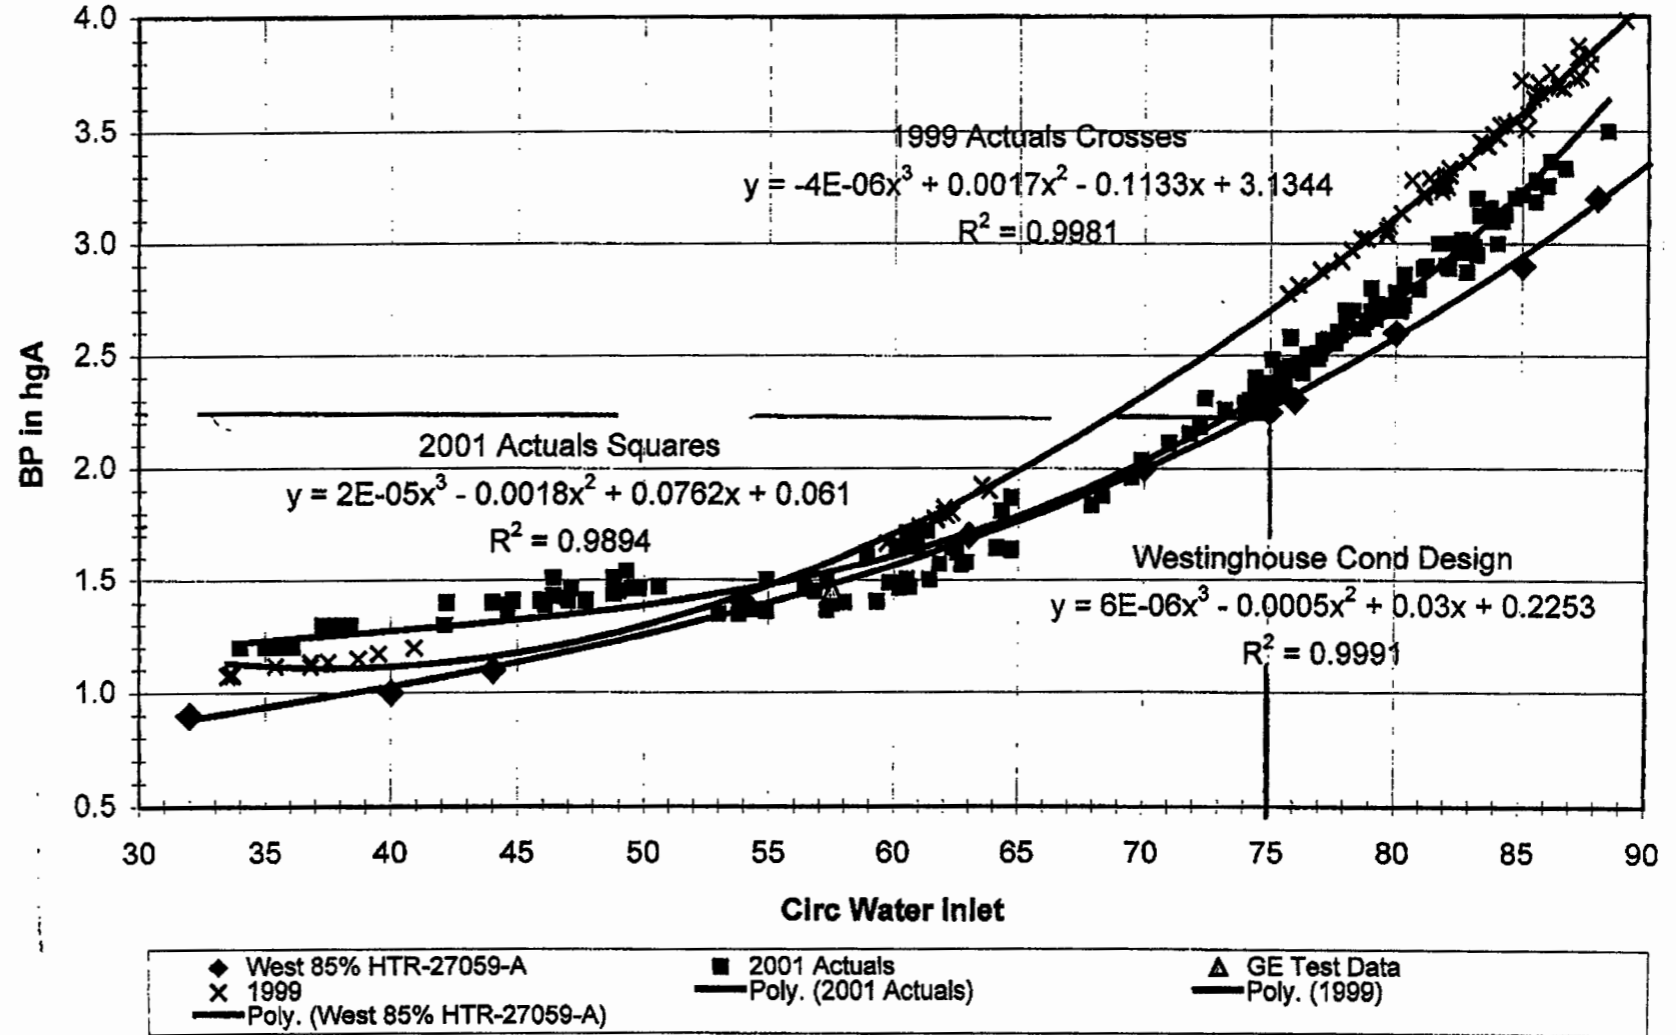
Figure 1:
BP vs Inlet Temp 1967 Westinghouse vs 1999 and 2001 Actuals

The VY condenser was designed to achieve a 2.25 in hgA back pressure with 75²F inlet water at full power with 85% cleanliness factor. As shown in Figure 1, based on 2001 plant data, the condenser performed at design with 225 in hgA back pressure with 75F inlet water. While this is a performance is a testament to VY maintenance on this 30 year old condenser, in today economy, a VY condenser would be designed for lower back pressure with a higher inlet temperature.

With 85F inlet water the VY condenser back pressure was 3.2 in hgA. The condenser design curve would indicate backpressure should be 2.9 in hgA with 85²F inlet water. This may not be an indication of poor condenser performance. The condenser design curve assumes the heat load on the condenser is at the design 3605 Mbtu/hr. As shown in Figure 2 with a 3.2in hgA back pressure the turbine gross megawatt production is 531 MW, 7 MW less than the 538 MW GE turbine design value. This would indicate that the 0.3 in hgA increase in condenser pressure with 85⁹F inlet water may be partially due to poor turbine performance and increased condenser heat load.

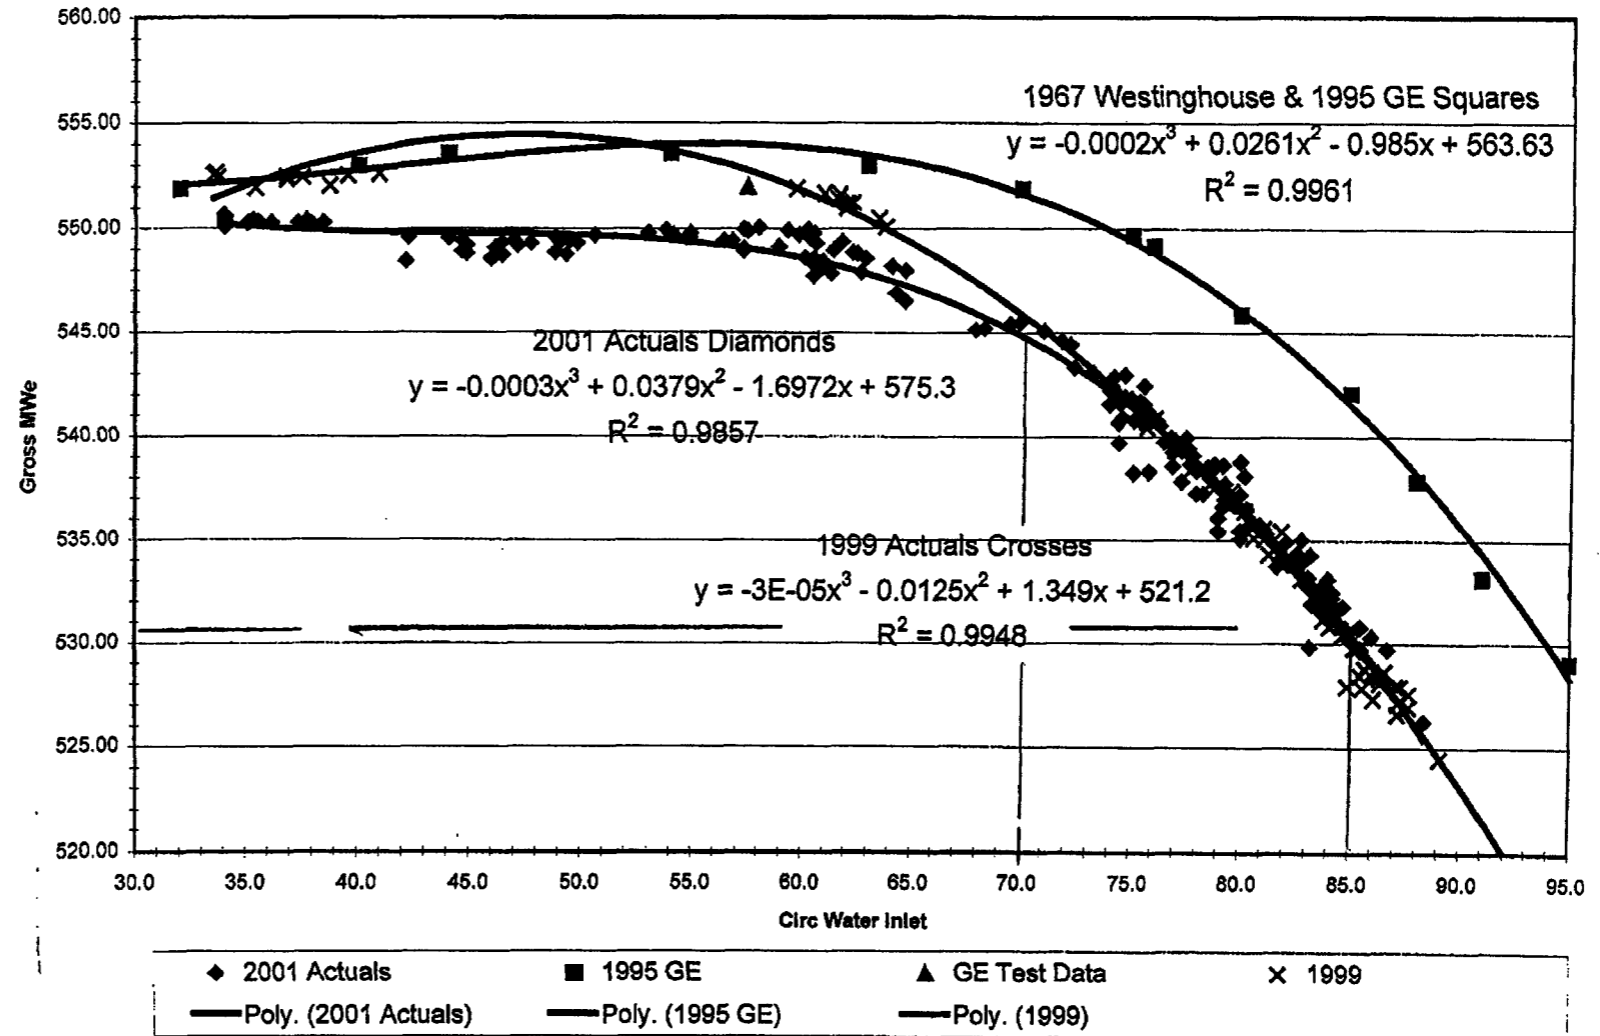
Figure 2
Gross MWe vs Inlet Temp

The key item to note in Figure 2 from the VY 2001 data is with 2 in hgA condenser backpressure (70²F inlet water temperature) VY generates 545 MW gross. With 3.2 in hgA condenser backpressure (85⁴F inlet water temperature) VY generates only 531 MW gross. This indicates that If the condenser tube bundles were redesigned with increase surface area (or U) to provide 2 in hgA pressure with 85⁹F inlet water the gross generation would be kept above 545 MW throughout most of the year. VY would realize a substantial increase output in the summer months when power is at peak demand. This translates to roughly a 5 MW increase in the average gross power generation and approximately \$5M¹ year in increased revenue.

Preliminary calculations indicate that redesigning the condenser bundles for an 85°F inlet temperature and 2 in hgA backpressure may be feasible. The bundle redesign would need to be matched to the circulation system capabilities. The downside is condenser bundle redesign and replacement would significantly increases the cost and installation window over a straight retube effort. It is estimated the bundle replacement and associated changes would

9. Action: Perform a detailed feasibility, schedule, and cost benefit assessment for retubing and bundle design and replacement.

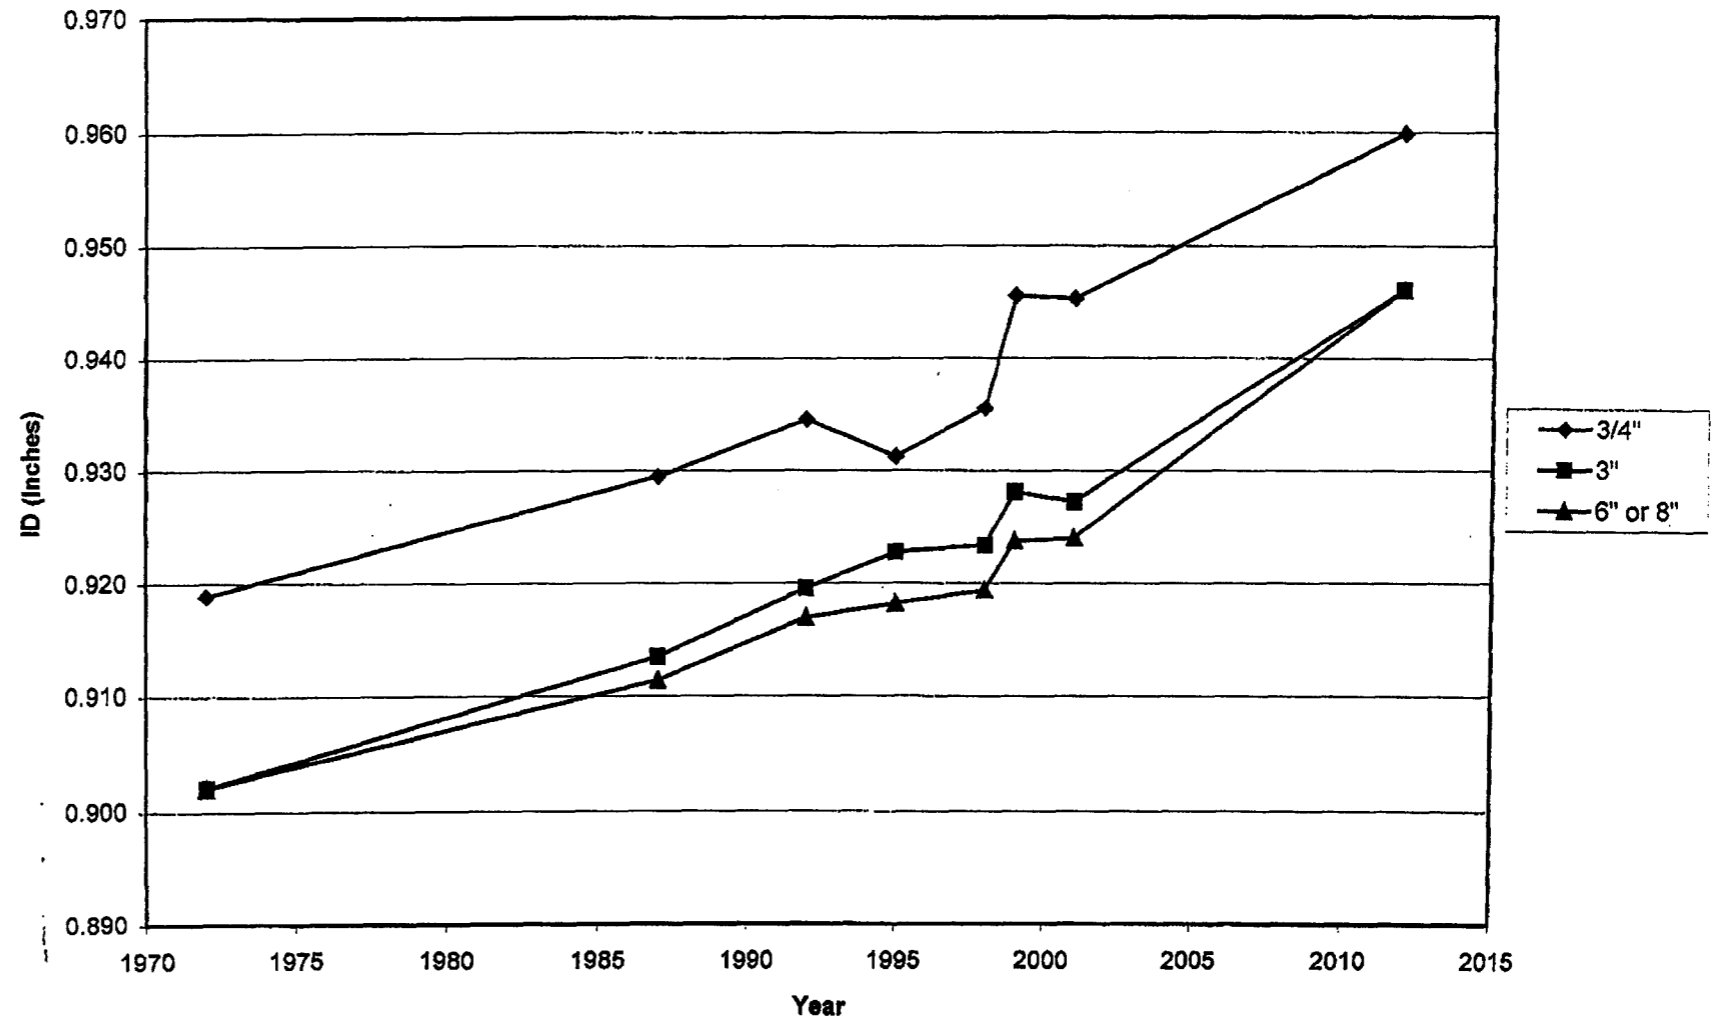
Figure 3
Average ID Inlet End

Brass tube ID erosion is tracked by measuring the tube ID with an Elliot gage. Figure 3 depicts average inlet side tube ID data from all Elliot gage testing. Figure 4 includes the maximum inlet side tube ID data. The tube ID's were measured in 1987, 1992, 1995, 1998, 1999, and 2001. The ID data depicted for 1972 represents the nominal thickness of the new tubes. The ID data depicted for 2012 is the 10 erosion limit. The erosion limit is based on 45% wall loss. With 45% loss [2] there would significant increase in the potential for tube sheet joint leakage, tube vibration and tube failure, and a forced outage.

The Elliot test tube sample will be expanded starting in RFO-23 to include ID erosion data of the most suspect tubes. The Elliot gage testing in RFO-23 will include rows of tubes tested in 1987 and 1992 to depict how erosion is progressing throughout the bundle. In addition a number of tubes in the NN and SS Inlet water-boxes that have the worst erosion at the tubesheet adjacent to the tube inlet will be included. For RFO 23 the 1995 to 2001 test sample of 120 tubes be expanded to include:
